**AIRCRAFT ACCIDENT REPORT**

The Final Report of the accident of Sri Lanka Airlines Flight UL 316, A 330-243, bearing Registration Number 4R-ALA, on 16th October 2005 at Bandaranaike International Airport, Katunayake, published by virtue of the powers vested with the Director General of Civil Aviation in terms of Section 270 (1) of the Air Navigation Regulations 1955 as amended.

**Final Report**

Accident of Sri Lankan Airlines Flight UL 316, Airbus A 330-243, 4R-ALA, on 16th October 2005 at Bandaranaike International Airport, Colombo, Katunayake, Sri Lanka.

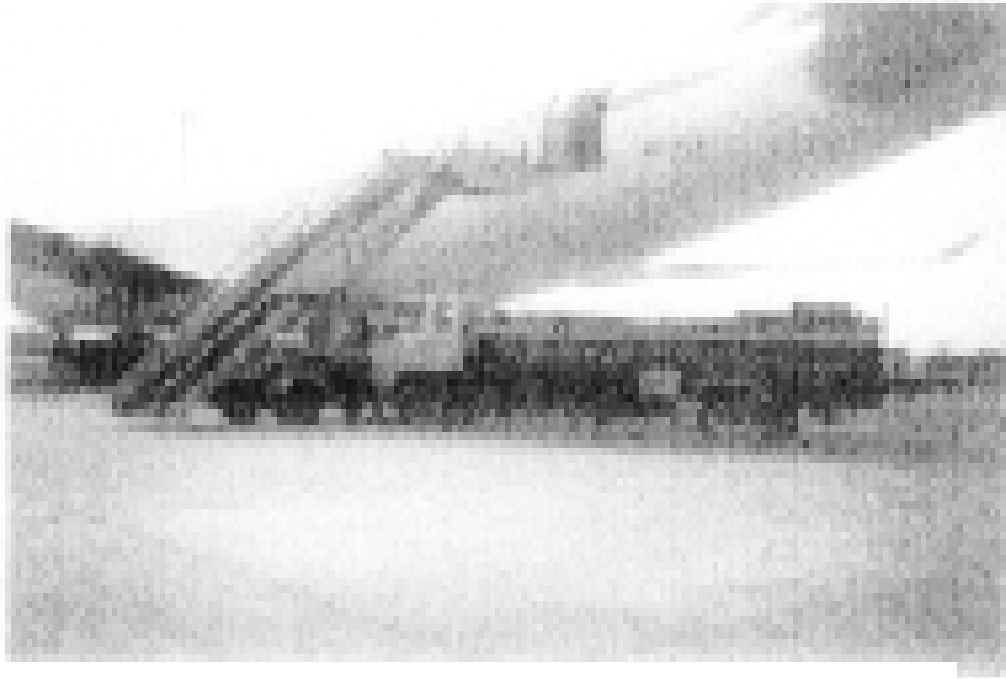
3.2. *Probable Cause* : The subjective MPV which was driven at a speed above the recommended speed of 5kmph, colliding with the stepladder used for passenger disembarkation, causing a sudden shift.

The Maintenance step vehicle after colliding with the stepladder

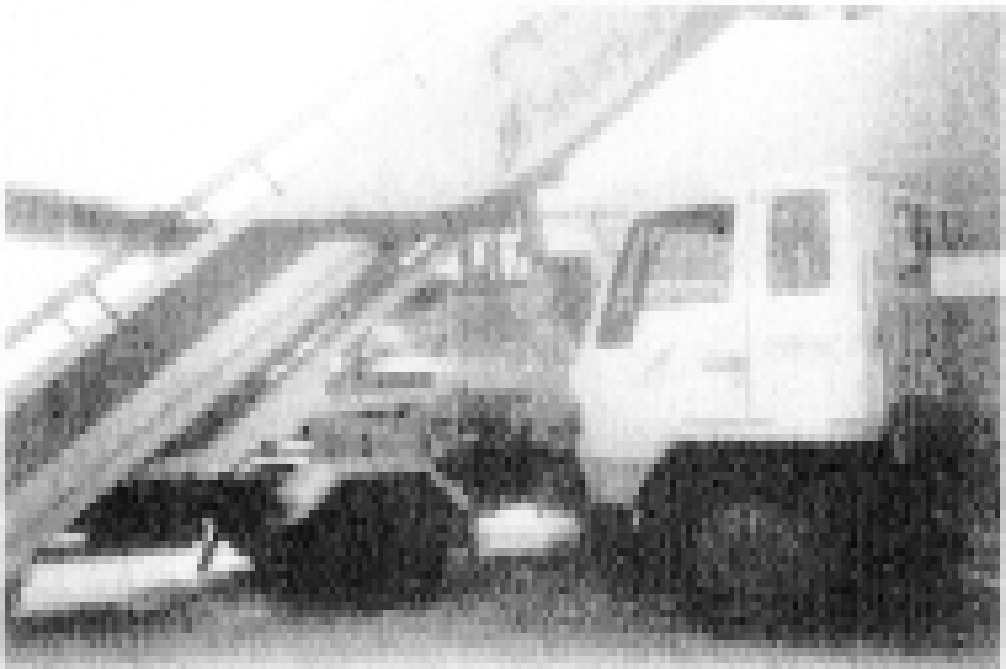
The Maintenance step vehicle stopped after colliding with the stepladder

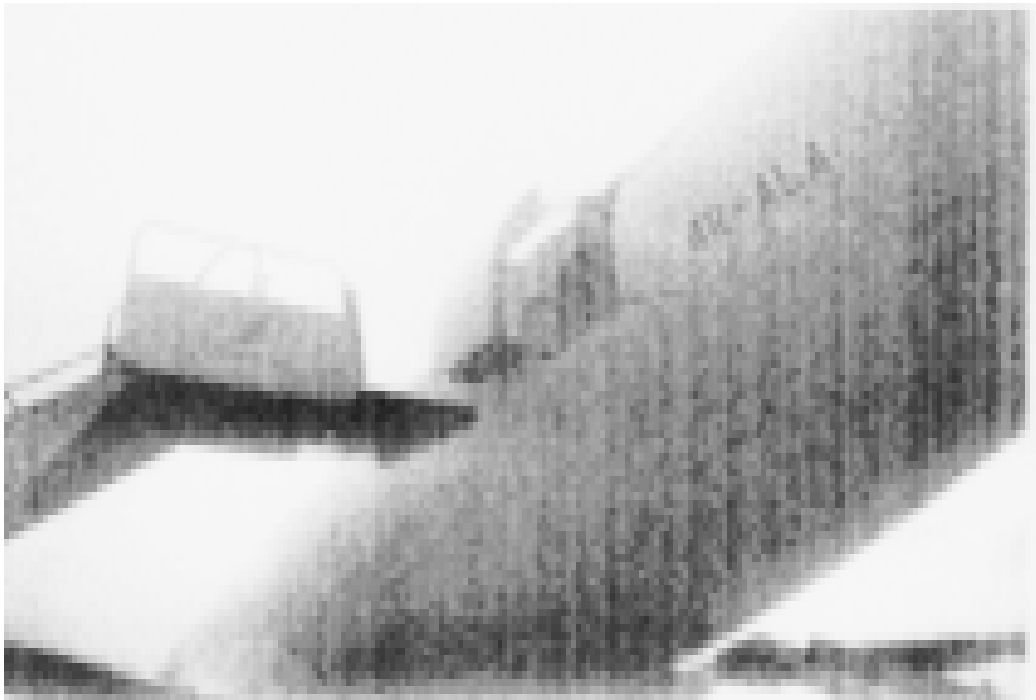
The stepladders were positioned at L1 and L4 doors for passenger disembarkation. All business class passengers disembarked through the L1 door stepladder and economy-class passengers started disembarking subsequently. While the passengers were disembarking through L4 door stepladder, the maintenance platform vehicle (i.e. MPV/Hi-Lifter), which approached the aircraft to position under the APU for maintenance collided with the L4 door stepladder displacing it and causing a passenger to fall through the gap thus created.

The gap created between the aircraft and the displaced stepladder

- 5. The respective airline in liaison with the Ground Handler shall control the number of passengers on stepladders when embarkation/disembarkation of passengers is in progress.
