AIRCRAFT ACCIDENT INVESTIGATION REPORT

FINAL REPORT

ACCIDENT OF SAUDI ARABIAN AIRLINES FLIGHT SV-781, BOEING 747-368, REGISTRATION HZ-AIP,

AT BANDARANAIKE INTERNATIONAL AIRPORT
KATUNAYAKE - SRI LANKA

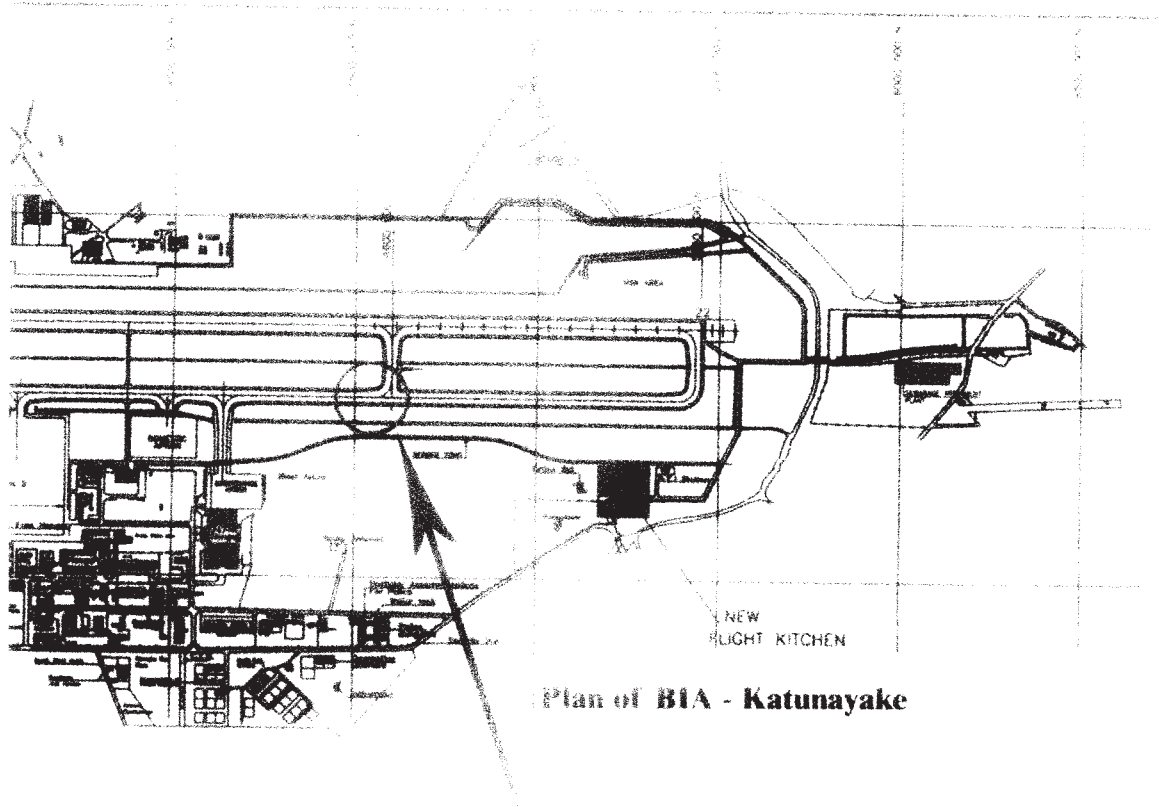
APPENDIX I

*Aircraft Parked at Isolation
Parking Position.*
